RAPID APPRAISAL PROCESS

Pixley ID

October 2017

IRRIGATION TRAINING & RESEARCH CENTER

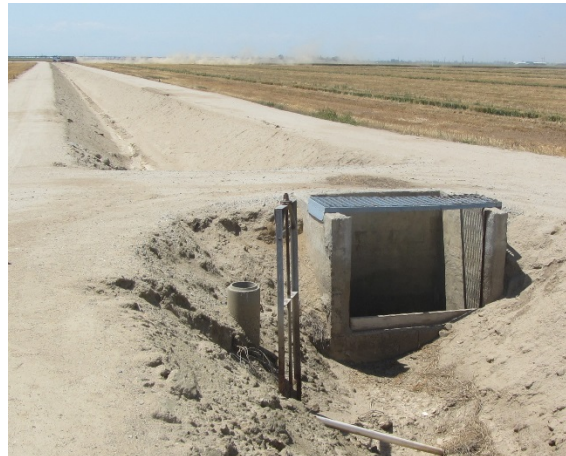
Check structures along the canal laterals are very basic, with flashboard designs as seen in Figure 6 through Figure 8.

Figure 6. Typical check structure and turnout on the North Canal. Typical flow rate is 15-20 CFS.

For these small canals and structures, no serious engineering design is needed. It is recommended that PIXID staff visit Chowchilla ID to examine the relatively small but longer flashboard weirs that have been built in front of similar check structures with similar flow rates. An example is shown in Figure 13. Simplistically, by making the overflow length four times as great, there will be only 25% as much water level fluctuation in the canal. The upstream-facing design is recommended. It is important to pour a thick enough floor so that the floor does not float at low flow rates.

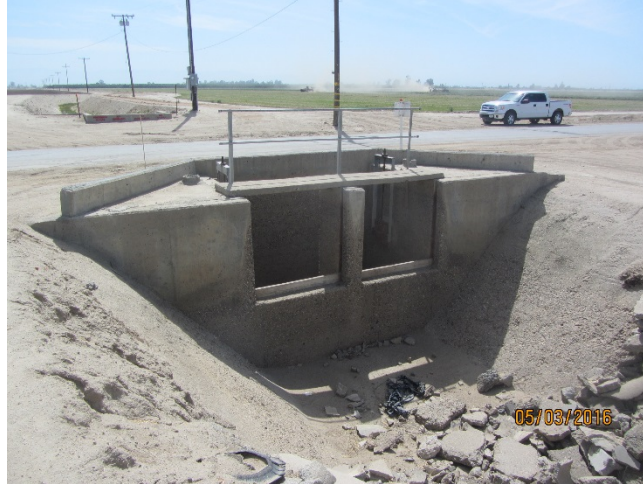
Figure 7. Lateral 3 check structure, looking from downstream side

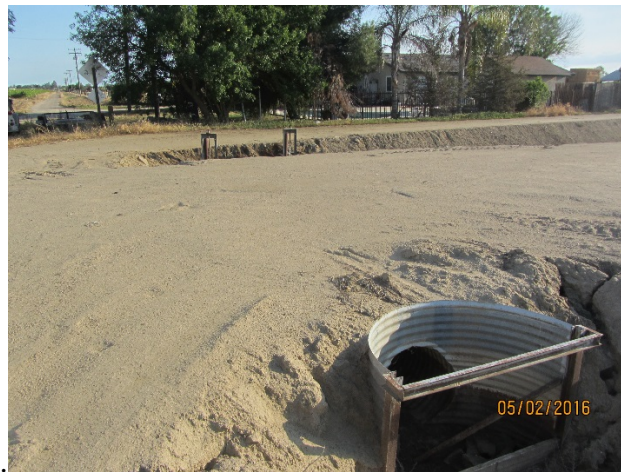
Figure 8. Old vertical culvert-check

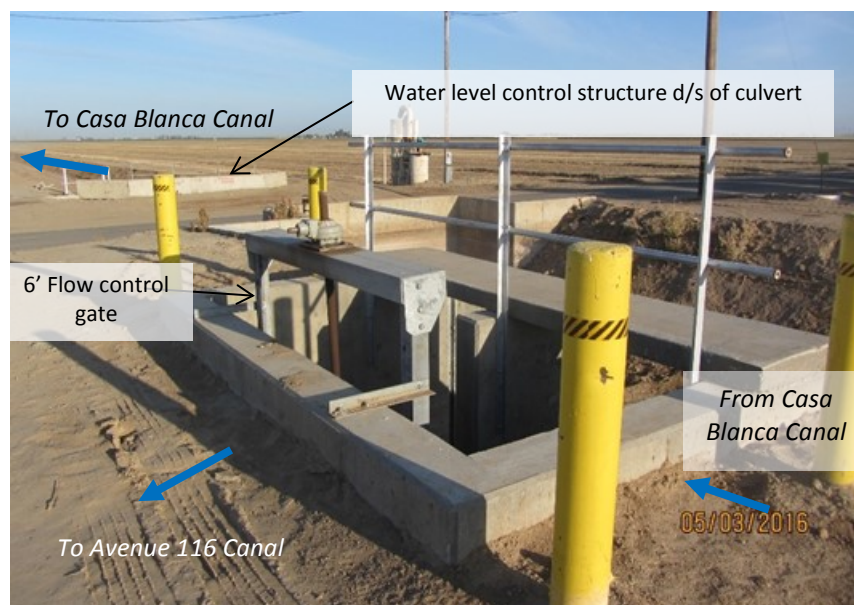
1. A concrete diversion box on the Casa Blanca Canal (Figure 19) diverts flow to the head of the Avenue 116 Canal through a 6' Waterman flow control gate.
2. There are three flashboard bays in the Casa Blanca Canal directly downstream of the two culvert pipes (Figure 20).
 - a. Each flashboard bay is approximately 65" wide.
 - b. There are two farmer turnouts directly upstream of the Casa Blanca check structure.

Figure 19. Existing diversion structure to Avenue 116 Canal from Casa Blanca Canal

1. Install a flume in the Avenue 116 Canal so that the flow rate into it can be measured. Before doing this, the water levels need to be surveyed at high flow rate and at low flow rate to verify that it is possible. Also, it is likely that the energy dissipation jump in the floor on the downstream side of the 116 entrance structure will need to be jackhammered out and smoothed out, to reduce the head loss there.

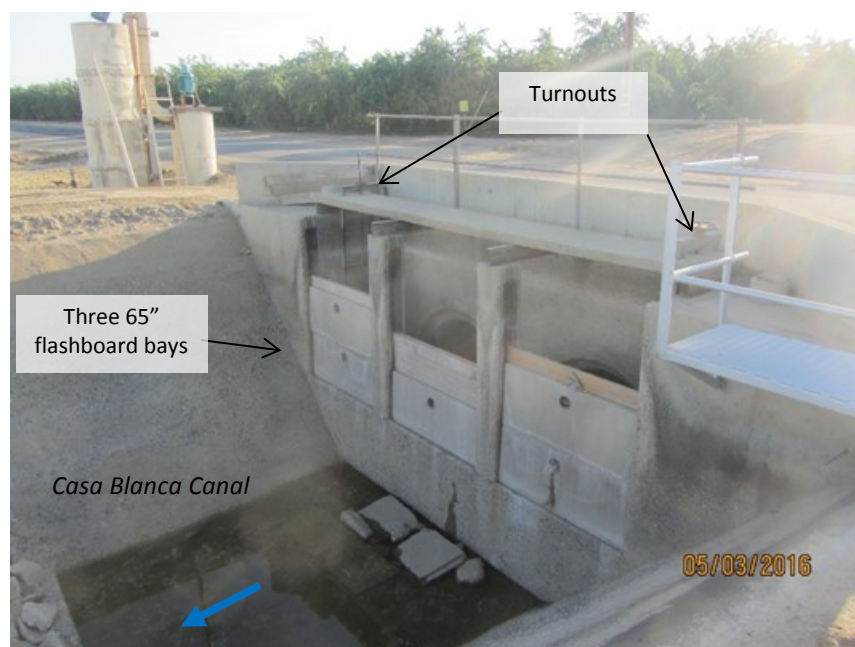
Figure 20. Check structure in the Casa Blanca Canal, just downstream of Avenue 116 Canal entrance

2. Install a downstream-facing long-crested weir in the center bay of the Casa Blanca Canal check structure. This will help stabilize the flow rate into the Avenue 116 Canal very quickly at any time a flow change is made, and will also help to maintain a constant flow rate into the Avenue 116 Canal after that flow rate change is made. A new flume in the Avenue 116 Canal will reduce the water level drop across the flow control structure at the head of the Avenue 116 Canal, making it more sensitive to changes in water level (over time) in the Casa Blanca Canal. The long-crested weir will minimize those Casa Blanca Canal water level fluctuations, and keep a constant flow going into the Avenue 116 Canal.

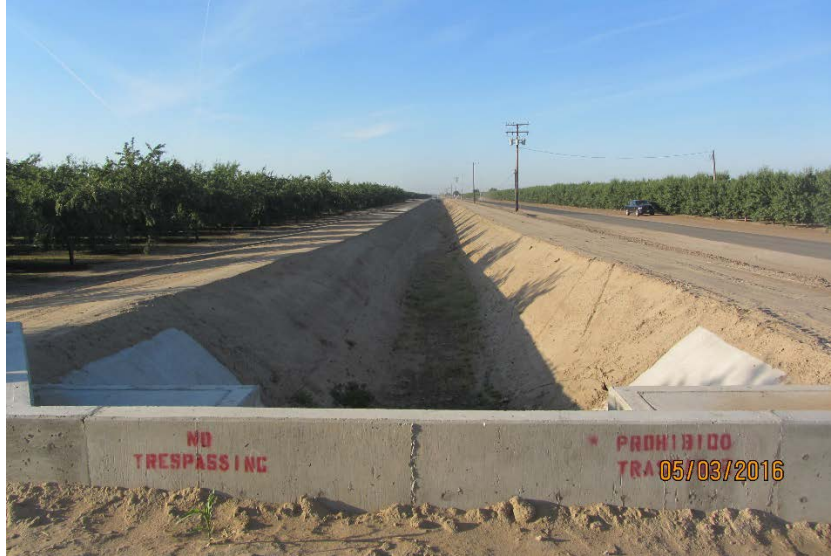
Figure 21. View of the Avenue 116 Canal, looking downstream from its entrance

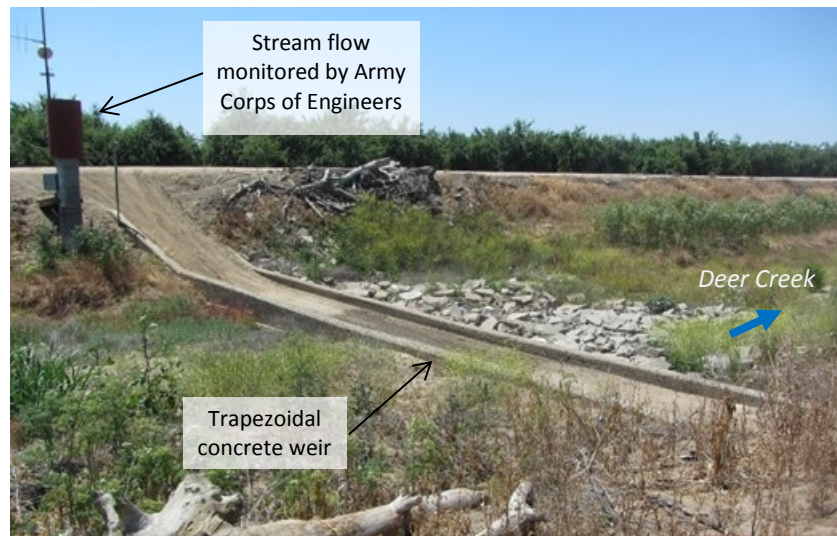
1. The structure is a trapezoidal concrete weir that is approximately 10.5 feet wide and spans the entire width of Deer Creek.
2. The weir also functions as a one lane road.
3. The downstream concrete wall of the weir is approximately 1.5 feet lower than the upstream wall of the weir.
4. The Army Corp of Engineers has a gauging station that collects data of flows in Deer Creek.
 - a. Flows are recorded weekly and supplied on the California Data Exchange Center (CDEC) website.
 - b. District staff reviews flows on a weekly basis and will make adjustments at the heads of the East Main and West Main Canal accordingly.

Figure 22. Existing Trenton Weir in Deer Creek used for flow measurement

This is by no means a standard measurement structure, and it is likely sensitive to the downstream channel conditions. However, this is likely not a high priority site unless it is used to determine water rights. It appears that its most important use is to estimate flood flow rates. It is too large to accurately estimate smaller flow rates of 200 CFS.

Unless this is an important site, it is recommended that PIXID focus on improving the flow rate measurement into the downstream canals, rather than modifying this structure.

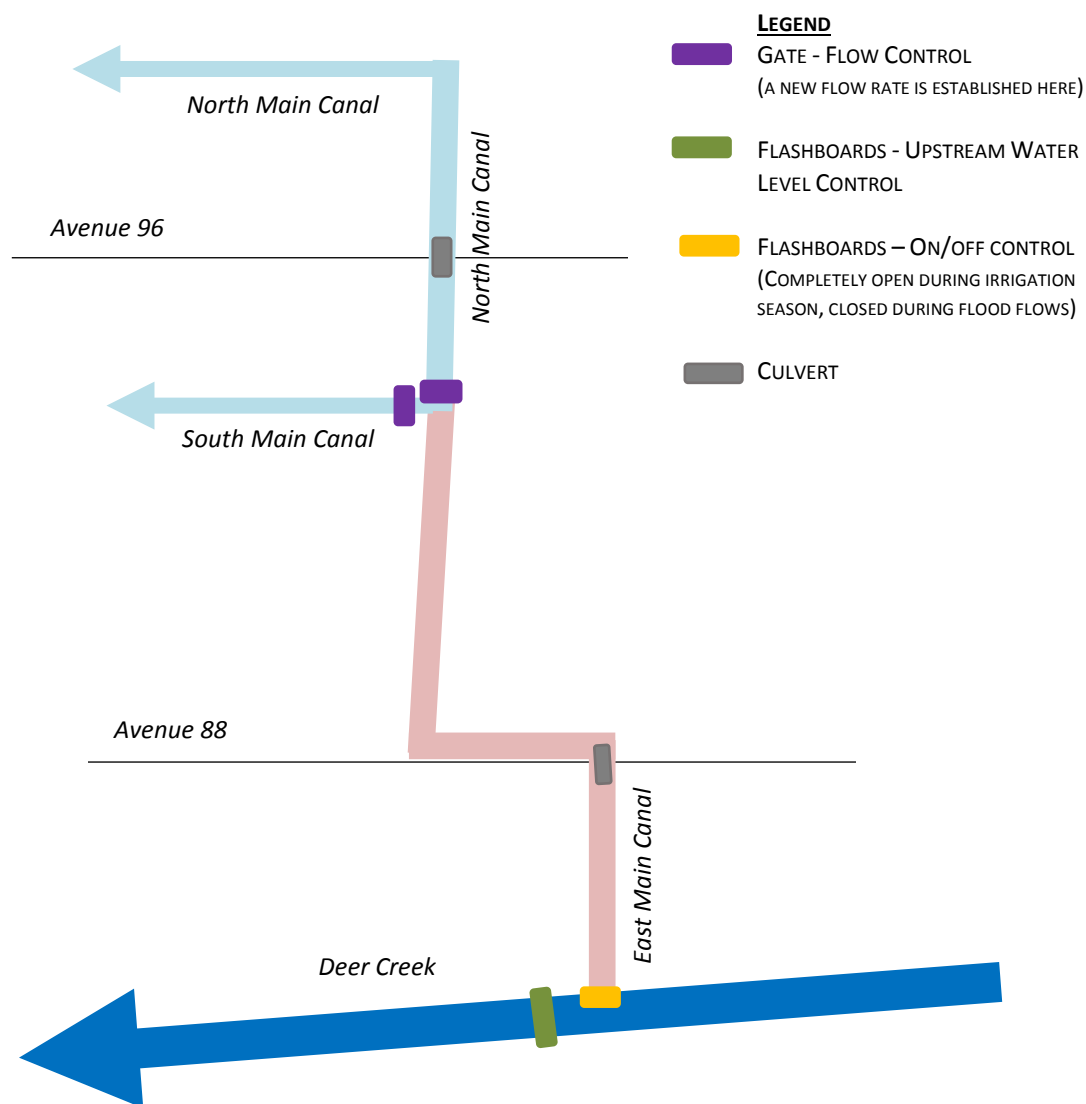
Figure 23. Current of the head of the East Main Canal

1. A diversion dam in Deer Creek (Figure 24) provides upstream water level control for the East Main Canal. Flow variations pass over the diversion dam and continue down Deer Creek to service the West Main Canal. The structure is composed of twelve flashboard bays that are each approximately 64" wide.
2. A flashboard structure at the head of the East Main Canal (Figure 25) is used for on/off control of the canal. During the irrigation season, the boards are removed so that the first section of the East Main Canal has the same water level as does Deer Creek. Boards are only installed in the structure to prevent winter flood flows in Deer Creek from entering the canal.

3. Average flow diverted to the East Main canal is approximately 30 CFS.
 - a. Flows are diverted through a 30" ARMCO gate to the North Main Canal:
 - i. average of 15 CFS

- ii. maximum of 20-25 CFS
 - b. Flows are diverted through a 36" ARMCO gate to the South Canal:
 - i. average of 15 CFS
4. It has been difficult for district staff to divert necessary flows into the East Main Canal. Land subsidence is suspected as the cause.

5. A preliminary survey conducted by the ITRC of the East Main Canal starting at Deer Creek and terminating at the head of the North Canal shows that there is only about **0.18 ft** of head loss from the High Water Level (HWL) in Deer Creek and the HWL at the head of the North Canal. The elevations of the canal bank, going north until the North Canal turns west, are almost all the same. Basically, there is very little slope to enable large flows to move along the East Main Canal.

6. There are roads on both sides of the canal, which will make it difficult to widen the canal.

The following modifications can be considered for the East Main Canal:

1. The design of the Avenue 116 Canal evidently assumed that some of its flow could eventually continue south to the Pixley North Canal. However, there is a rise in elevation going straight south from the initial southerly leg of the Avenue 116 Canal, and connecting to the East Main Canal. This would make it difficult to flow via gravity along that route.

2. It may be possible to install the flashboards in Deer Creek several inches higher.
3. The road crossing Avenue 88 creates a flow restriction, as seen in Figure 26. It is understood that there had been no flow for several years, and it can be expected that after that time, the 53" ID culvert would be partially plugged. However, the following items can be noted:

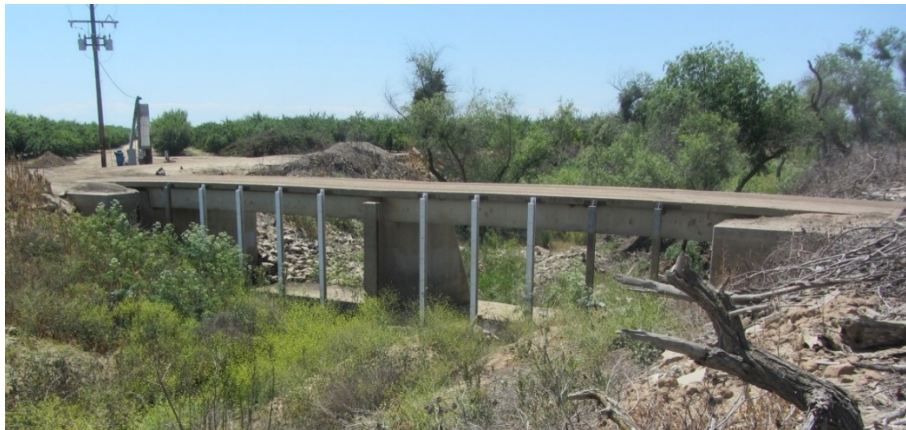
Figure 24. Diversion dam on Deer Creek at the head of the East Main Canal

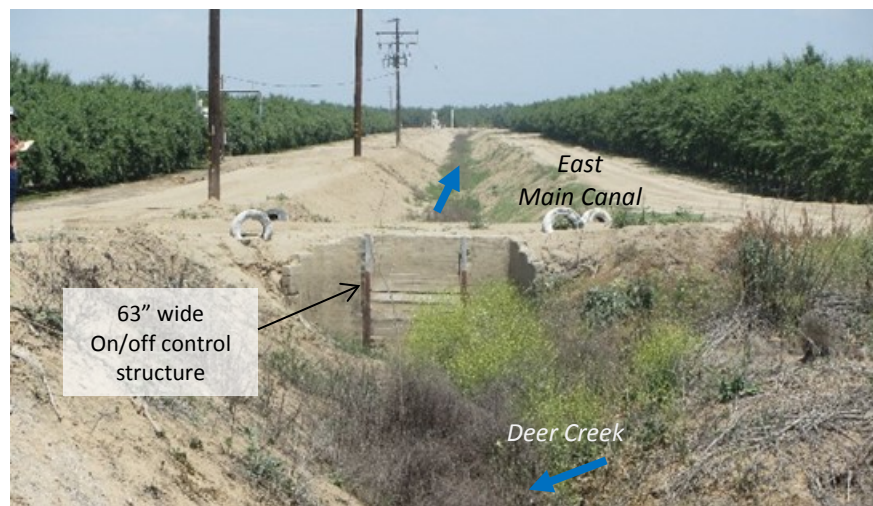
Figure 25. Existing structure at the head of the East Main Canal used for on/off control. During the irrigation season, the boards are removed.

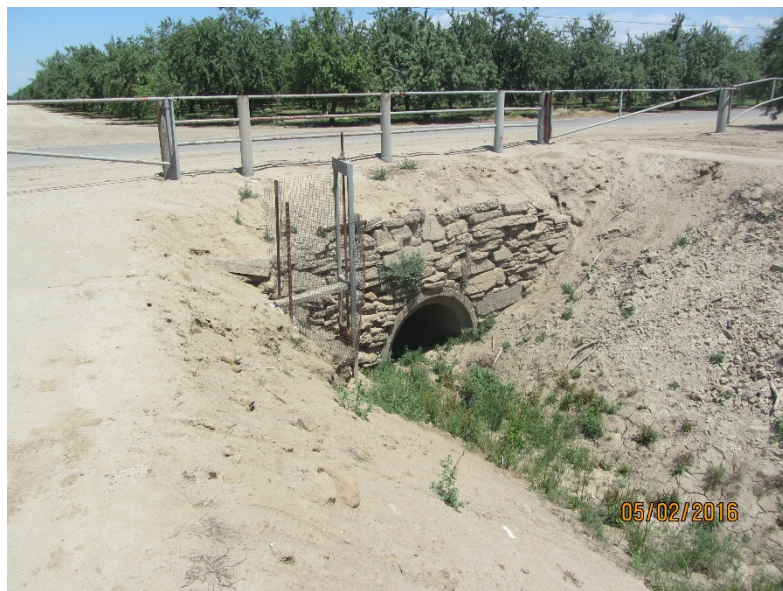
- a. If the culvert is kept clean, there will be about 0.25 feet of head loss across the whole structure. There is little that can be done in this case to reduce that loss.

Figure 26. Avenue 88 culvert of the East Main Canal

- b. A key goal is to keep this and other restricting culverts clean. Shotcreting the channel for about 40' upstream of the culvert entrance can be considered to help keep it clean.

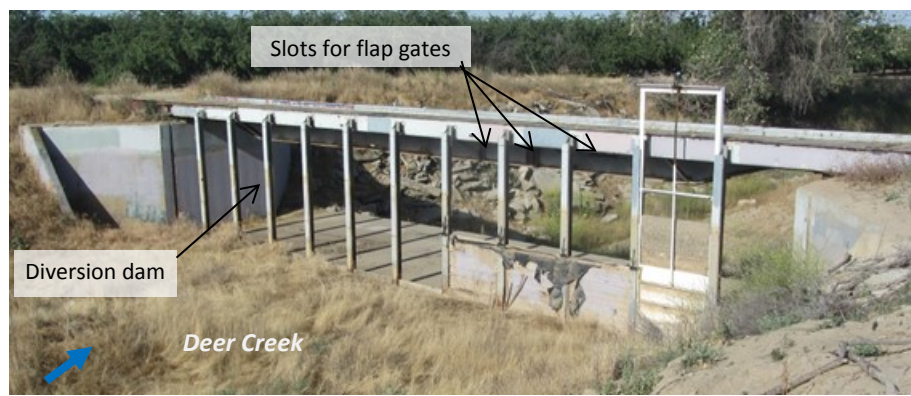
Figure 29. View “A” from Figure 28. Existing diversion dam on Deer Creek at the head of the Upper West Main Canal. The original flap gates were removed at the time of the photo

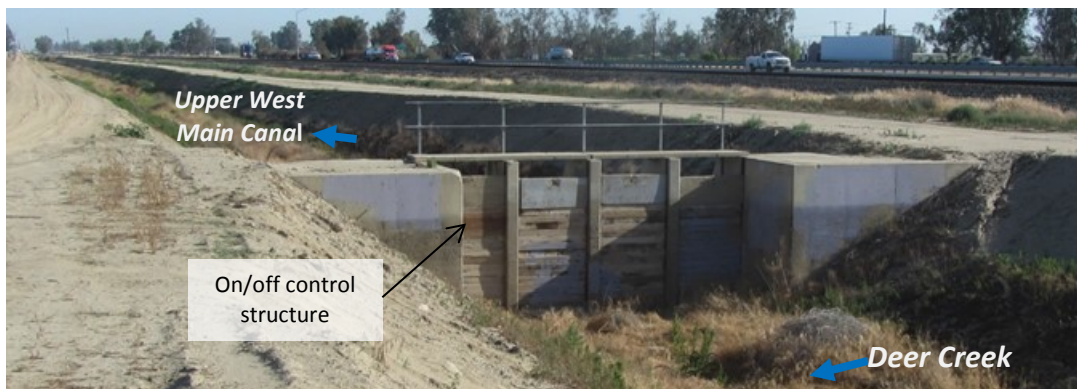
Figure 30. View “B” from Figure 28. Existing structure at the head of the Upper West Main Canal used for on/off control. During the irrigation season, the structure is wide open.

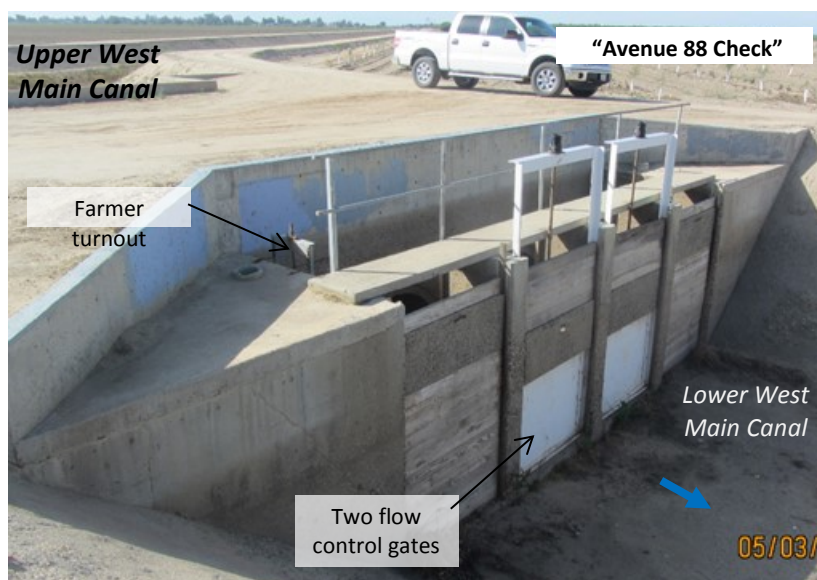
Figure 31. View “C” from Figure 28. Avenue 88 Check; Flow control gates at the entrance to the Lower West Main Canal

Figure 34 shows the proposed modifications to the Avenue 88 Check. A 100 ft long (minimum effective length) downstream facing long-crested weir (LCW) without a walkway top will be constructed to maintain the upstream water level in the Upper West Main Canal and Deer Creek.

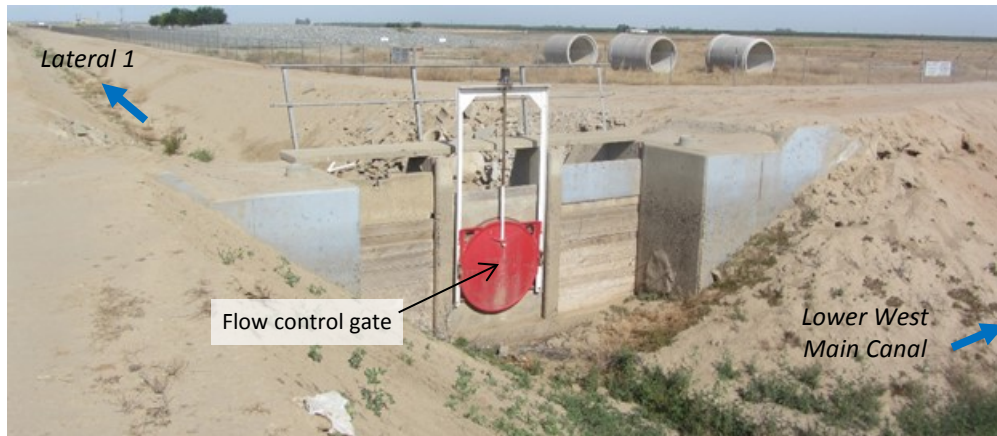
1. A target flow rate of approximately 100 CFS is diverted at the Avenue 88 Check into the Lower West Main Canal from the Upper West Main Canal.
2. Approximately 35-50 CFS is diverted into both Lateral 1 and Lateral 2 through manually operated 48" Waterman gates.
3. At the head of Lateral 3, a circular gate and flashboard combination structure regulates the water level in the Lower West Main Canal. The 48" Waterman is used to pass majority of the flow with the flow variations passing over the two outside flashboard bases into Lateral 3.

Figure 36. Existing Lateral 1 flow control headgate on the Lower West Main Canal

1. The existing Lateral 1 head structure will be modified to include an 80' long-crested weir that will provide water level control in the Lower West Main Canal while simultaneously passing all flow variations into Lateral 1. The variations will flow west towards the Micheilli # 1 Basin where the variations will be captured and re-regulated.
2. The existing structure at the head of Lateral 3 will only provide flow control to set a target flow rate in to Lateral 3.
3. SCADA will be used to remotely monitor water levels in the reservoirs. If a reservoir becomes too full, excess flows can be diverted to another reservoir.

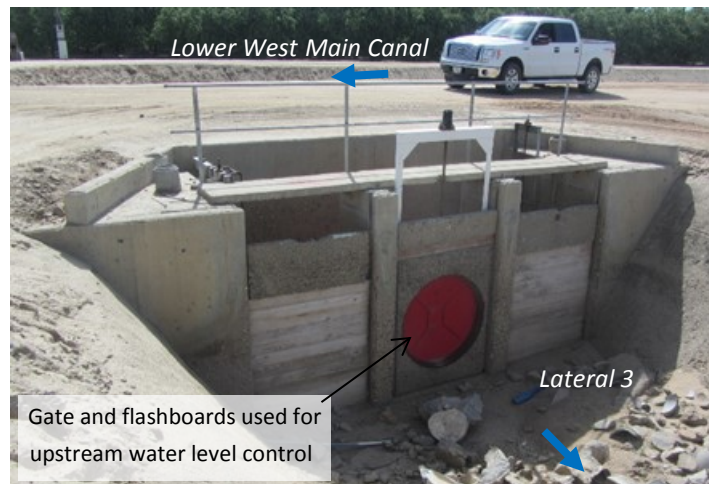
Figure 37. Existing check structure at start of Lateral 3 that provides upstream water level control in the Lower West Main Canal
