RAPID APPRAISAL PROCESS

Pixley ID

October 2017

IRRIGATION TRAINING & RESEARCH CENTER

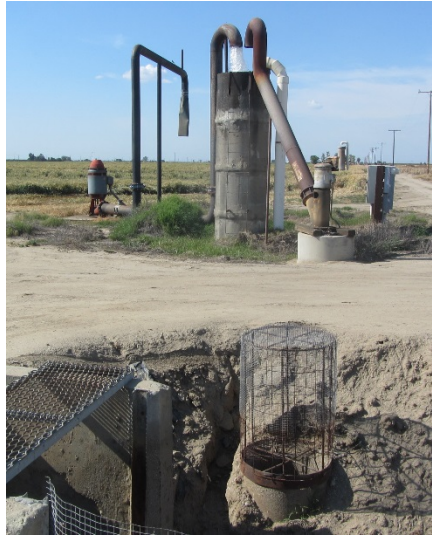
Figure 5. Typical conjunctive use system in PIXID. A well pump (on the left) is discharging into a standpipe. A low lift pump (right side) will lift canal water into the same standpipe.

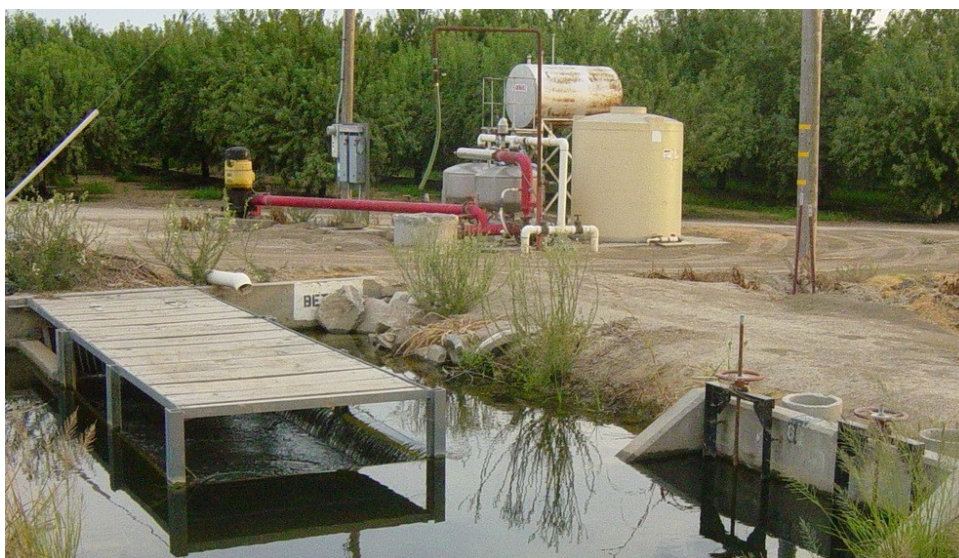
Figure 13. Retrofitted long-crested weir at Chowchilla ID

For these small canals and structures, no serious engineering design is needed. It is recommended that PIXID staff visit Chowchilla ID to examine the relatively small but longer flashboard weirs that have been built in front of similar check structures with similar flow rates. An example is shown in Figure 13. Simplistically, by making the overflow length four times as great, there will be only 25% as much water level fluctuation in the canal. The upstream-facing design is recommended. It is important to pour a thick enough floor so that the floor does not float at low flow rates.

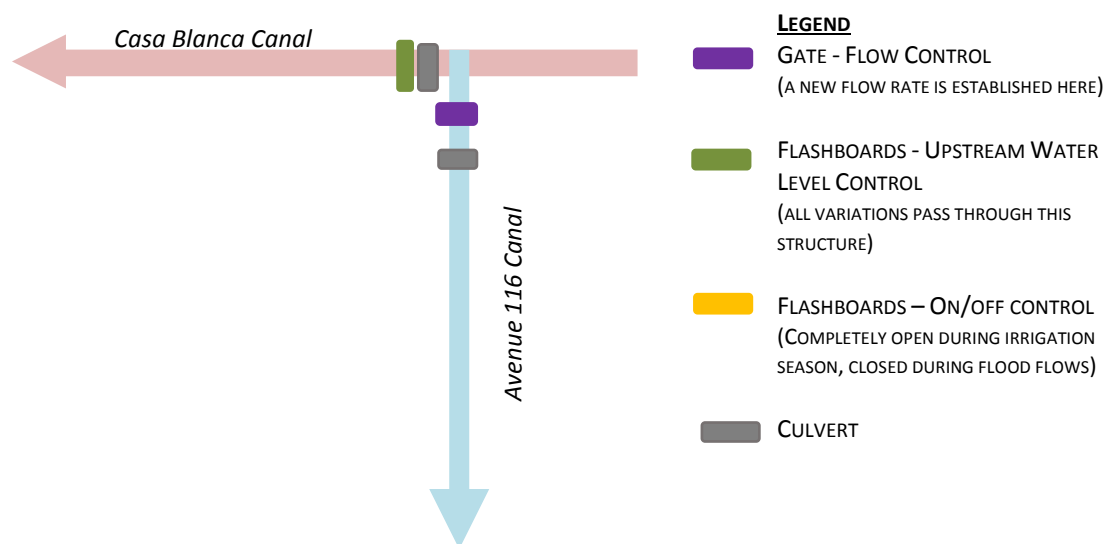
Figure 18. Current operation at Casa Blanca Canal and Avenue 116 Canal

1. A concrete diversion box on the Casa Blanca Canal (Figure 19) diverts flow to the head of the Avenue 116 Canal through a 6' Waterman flow control gate.
2. There are three flashboard bays in the Casa Blanca Canal directly downstream of the two culvert pipes (Figure 20).
 - a. Each flashboard bay is approximately 65" wide.
 - b. There are two farmer turnouts directly upstream of the Casa Blanca check structure.

1. Install a flume in the Avenue 116 Canal so that the flow rate into it can be measured. Before doing this, the water levels need to be surveyed at high flow rate and at low flow rate to verify that it is possible. Also, it is likely that the energy dissipation jump in the floor on the downstream side of the 116 entrance structure will need to be jackhammered out and smoothed out, to reduce the head loss there.

2. Install a downstream-facing long-crested weir in the center bay of the Casa Blanca Canal check structure. This will help stabilize the flow rate into the Avenue 116 Canal very quickly at any time a flow change is made, and will also help to maintain a constant flow rate into the Avenue 116 Canal after that flow rate change is made. A new flume in the Avenue 116 Canal will reduce the water level drop across the flow control structure at the head of the Avenue 116 Canal, making it more sensitive to changes in water level (over time) in the Casa Blanca Canal. The long-crested weir will minimize those Casa Blanca Canal water level fluctuations, and keep a constant flow going into the Avenue 116 Canal.

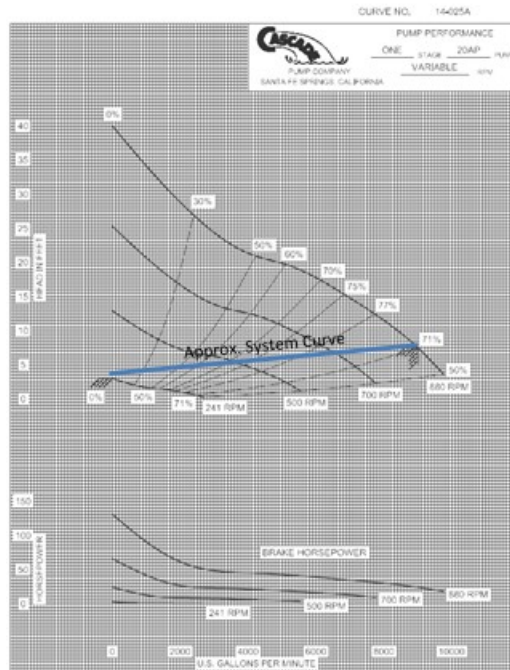
Figure 27. Cascade pump system curves

4. The major recommendation is to install a VFD-equipped pump to supply the North Canal, located at the bifurcation of the North and South Canals. There must be two considerations:
 - a. This is a very low lift pump, and it must be carefully selected to provide a range of flows between 5 and 20 CFS without having vibration problems. Most pumps of this type are unstable under VFD operation. Figure 27 shows example system/pump curves for a Cascade 20AP pump that is suitable for VFD operation. At 20 CFS, this would require about 30 HP into the motor.

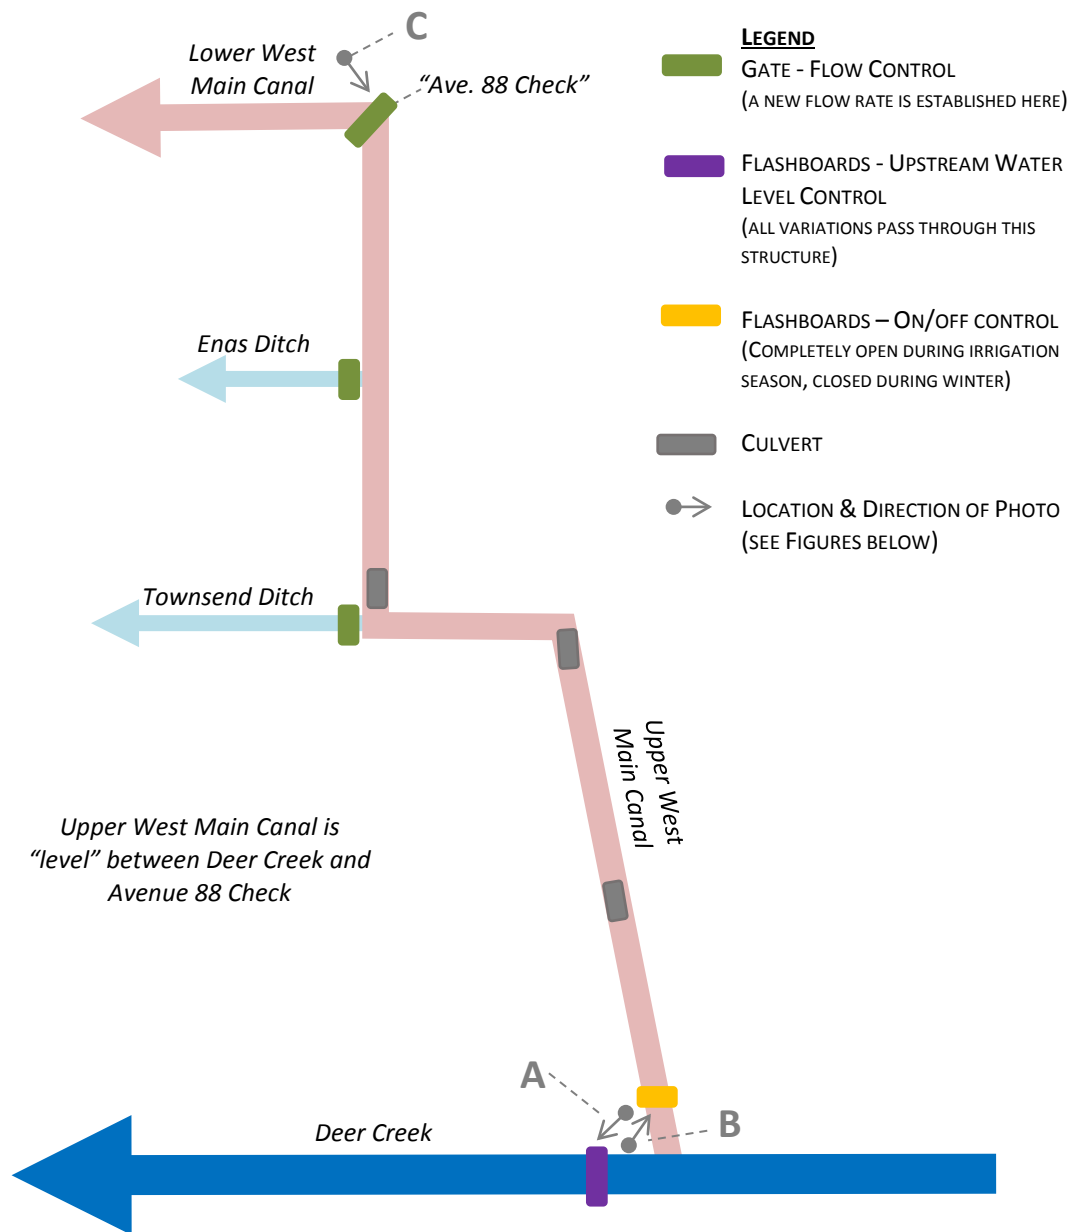
Figure 28. Current operation at Deer Creek and Upper West Main Canal

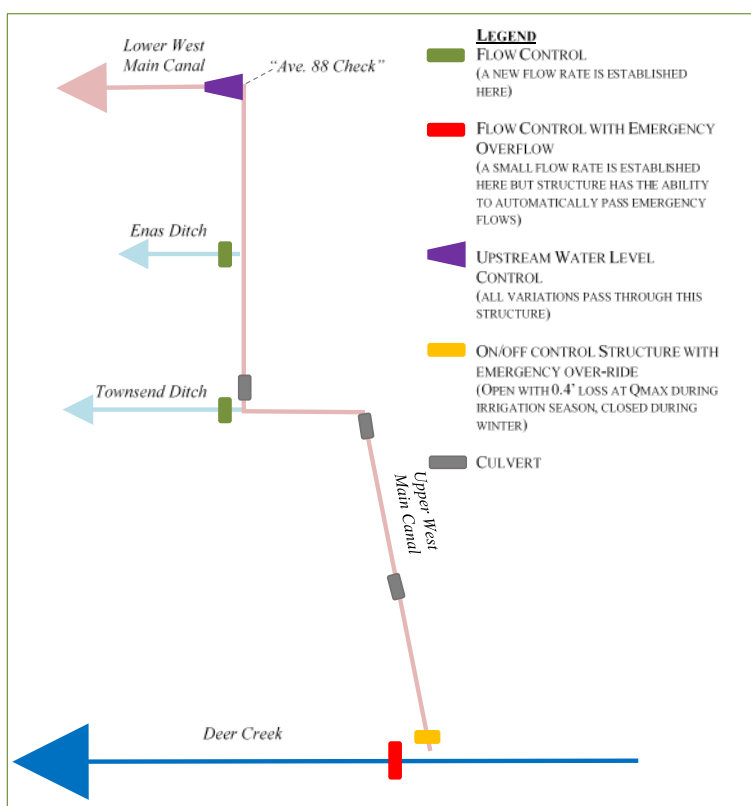
Figure 32. New operation of the Deer Creek and the Upper West Main Canal

1. The Deer Creek diversion dam will continue to operate as-is during the irrigation season. The only water that will continue to flow downstream will be regulated through the existing sluice gate.

- a. The sluice gate will be positioned to have about 0.4' of head loss at the expected *maximum* flow rate.
 - b. If a higher flow rate comes down Deer Creek, the water level upstream of the new sluice gate will rise. If the flow into the Upper Main Canal increases by 40%, the water level upstream of the sluice gate will rise by about 0.5'. This will be sufficient to send an alarm over the SCADA system.

- c. The sluice gate can be remotely (manually) operated from the office in case the flow is too high.
 - d. SCADA will provide information on the water levels upstream and downstream of the new sluice gate, as well as the sluice gate opening.

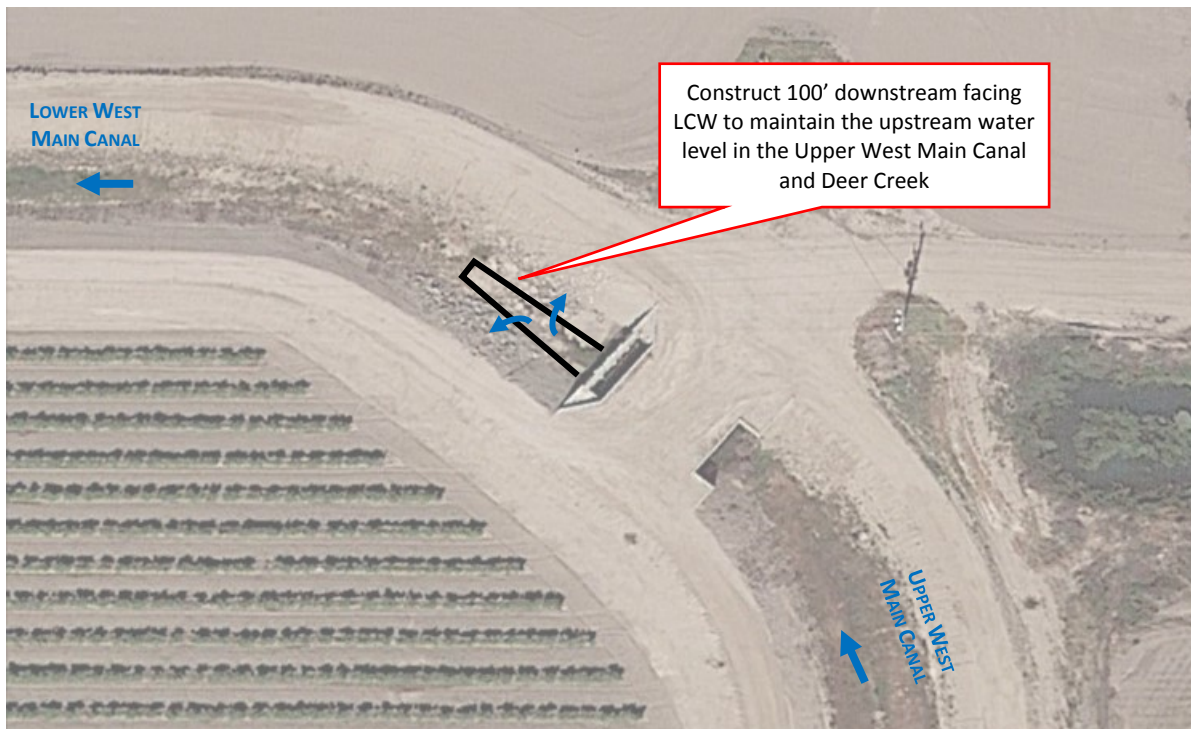
Figure 34. Modifications to the Avenue 88 Check

Figure 34 shows the proposed modifications to the Avenue 88 Check. A 100 ft long (minimum effective length) downstream facing long-crested weir (LCW) without a walkway top will be constructed to maintain the upstream water level in the Upper West Main Canal and Deer Creek.

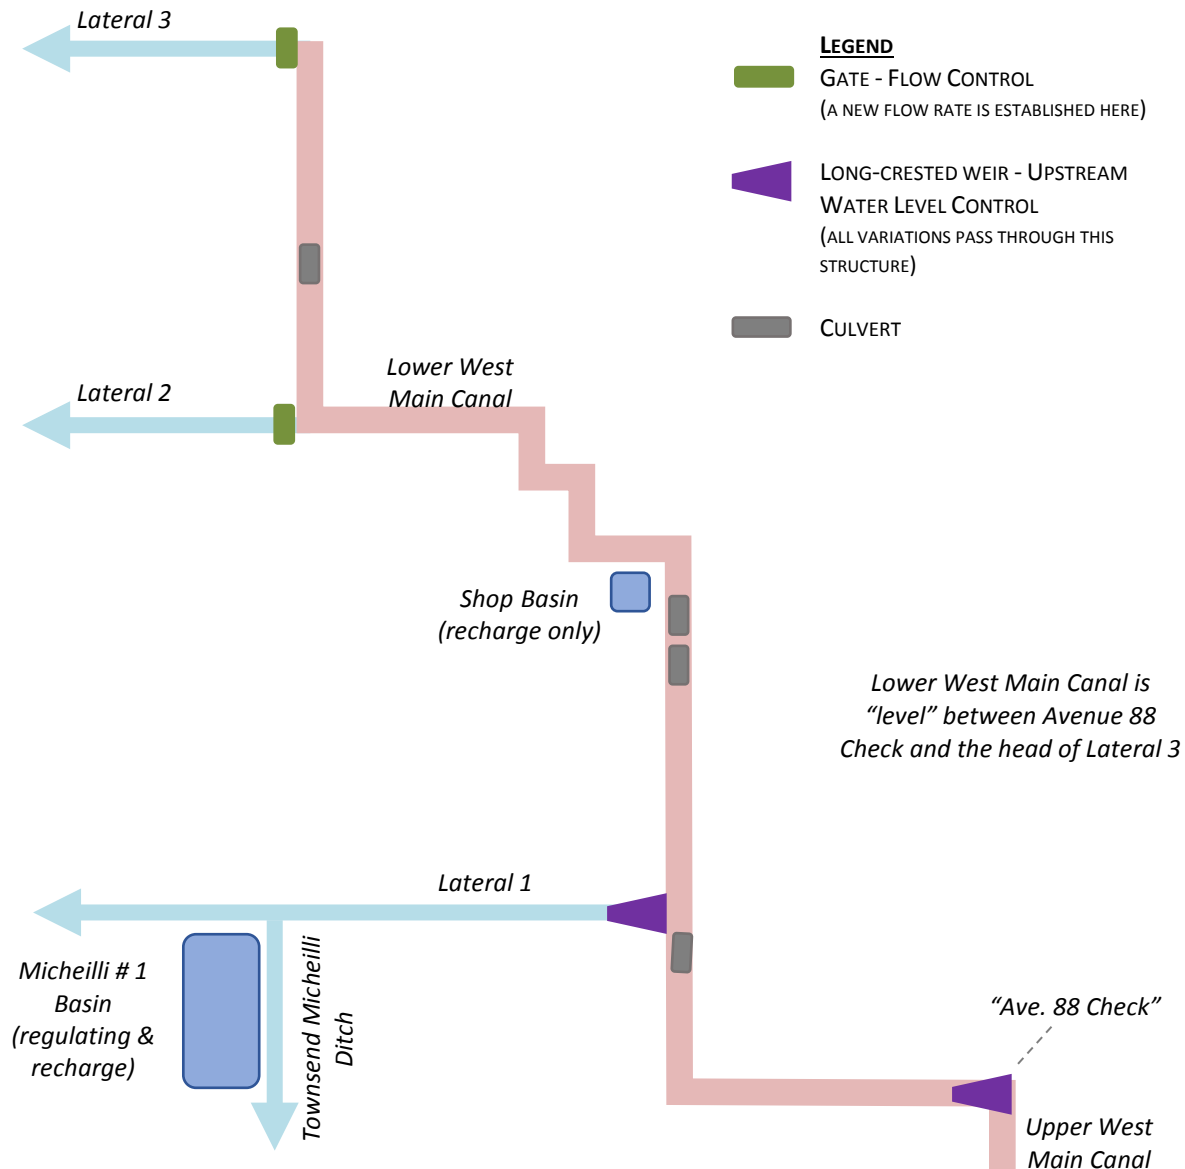
Figure 38. Future conceptual operation of the Lower West Main Canal

The functions of the existing structures at the head of Lateral 1 and Lateral 3 will be switched. Figure 38 shows the proposed new operations of the Lower West Main Canal. The new operations include:

1. The existing Lateral 1 head structure will be modified to include an 80' long-crested weir that will provide water level control in the Lower West Main Canal while simultaneously passing all flow variations into Lateral 1. The variations will flow west towards the Micheilli # 1 Basin where the variations will be captured and re-regulated.
2. The existing structure at the head of Lateral 3 will only provide flow control to set a target flow rate in to Lateral 3.
3. SCADA will be used to remotely monitor water levels in the reservoirs. If a reservoir becomes too full, excess flows can be diverted to another reservoir.

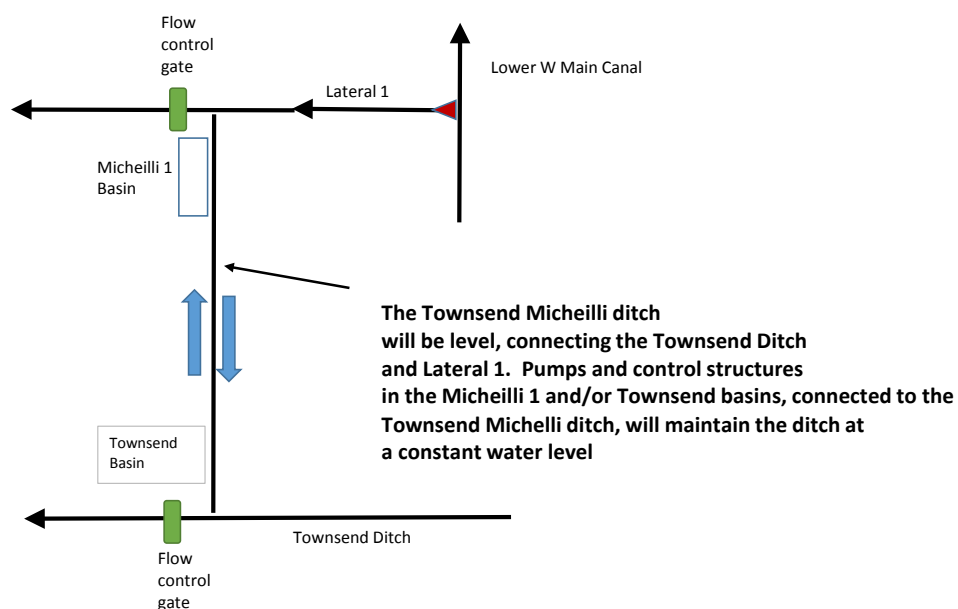
Figure 39. Proposed changes for the Townsend and Micheilli Basins

Earlier in this report, a plan was described for automatically moving the variable flows from the Deer Creek into Lateral 1. The strategy for improvement will require new hardware at both basins, as well as a new way of controlling water levels and flows. The basic strategy is seen in Figure 39.

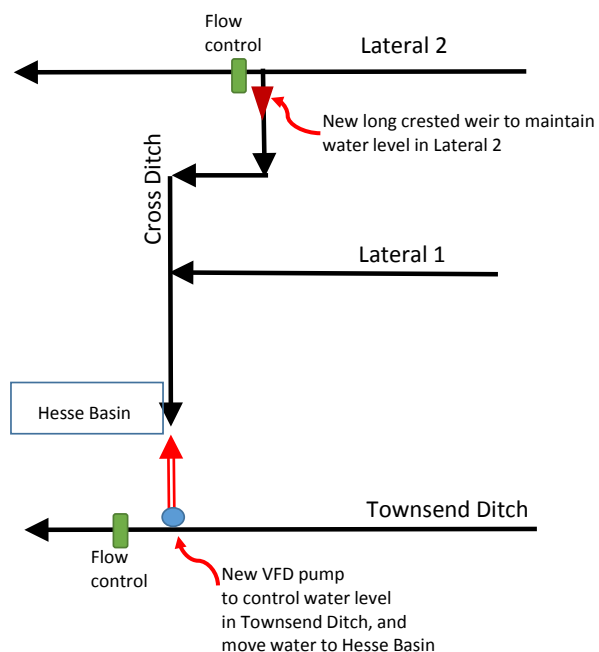
Figure 40. Proposed new controls on the Cross Ditch ends

Modifications are recommended for consideration at both the north and south ends of the Cross Ditch. With these modifications, the Hesse Basin will receive excess flows from the Townsend Ditch, Lateral 1, and Lateral 2. The proposed changes are shown in Figure 40.
